UNITED STATES COAST GUARD
U.S. Department of Homeland Security

MARINE SAFETY ALERT
Inspections and Compliance Directorate

Safety Alert 13-18

Let us enlighten you about LED lighting!
Potential interference of VHF-FM Radio and AIS Reception.

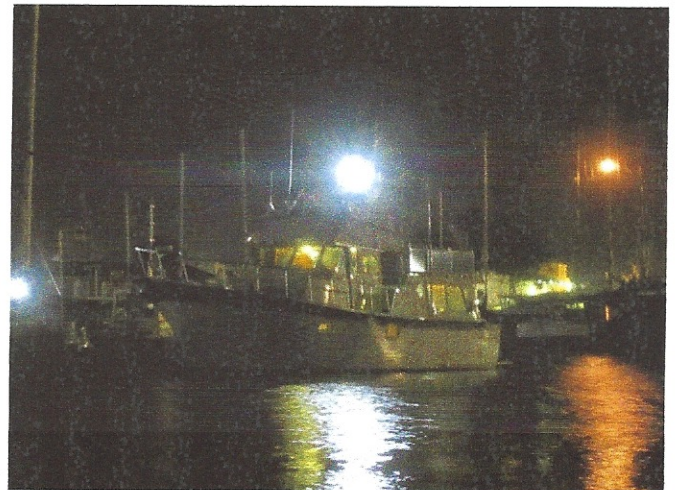
The U.S. Coast Guard has received reports from crews, ship owners, inspectors and other mariners regarding poor reception on VHF frequencies used for radiotelephone, digital selective calling (DSC) and automatic identification systems (AIS) when in the vicinity of light emitting diode (LED) lighting on-board ships (e.g., navigation lights, searchlights and floodlights, interior and exterior lights, adornment).

Radio frequency interference caused by these LED lamps were found to create potential safety hazards. For example, the maritime rescue coordination center in one port was unable to contact a ship involved in a traffic separation scheme incident by VHF radio. That ship also experienced very poor AIS reception. Other ships in different ports have experienced degradation of the VHF receivers, including AIS, caused by their LED navigation lights. LED lighting installed near VHF antennas has also shown to compound the reception.

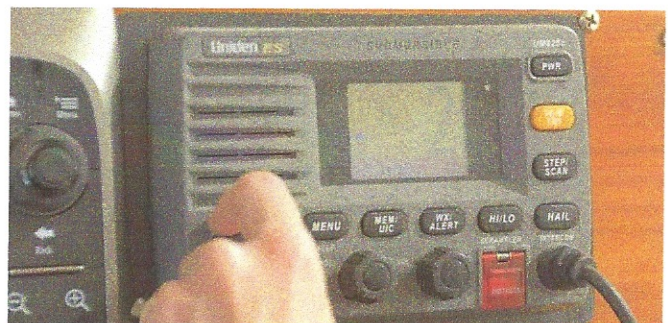
If the noise floor is found to have been raised, then it is likely that both shipboard VHF marine radio and AIS reception are being degraded by LED lighting.

1. Turn off LED light(s).
2. Tune the VHF radio to a quiet channel (e.g. Ch. 13).
3. Adjust the VHF radio's squelch control until the radio outputs audio noise.
4. Re-adjust the VHF radio's squelch control until the audio noise is quiet, only slightly above the noise threshold.

5. Turn on the LED light(s).
 - If the radio now outputs audio noise, then the LED lights have raised the noise floor. (Noise floor is generally the amount of interfering signals / static received beyond the specific signal or channel being monitored.)
6. If the radio does not output audio noise, then the LED lights have not raised the noise floor.
